Re Final Report on Birch Spring Investigation, CO-OP Mining Co., Bear Canyon Mine,
ACT/015/025, Outgoing File

RE: Birch Spring Findings for Technical Directive 005, Co-Op Mining Corporation, Bear Canyon Mine ACT/015/025, and Star Point Mine, ACT/007/006, Internal File

The Issue: The Reason for Decreased Flow at Birch Spring is Undetermined.

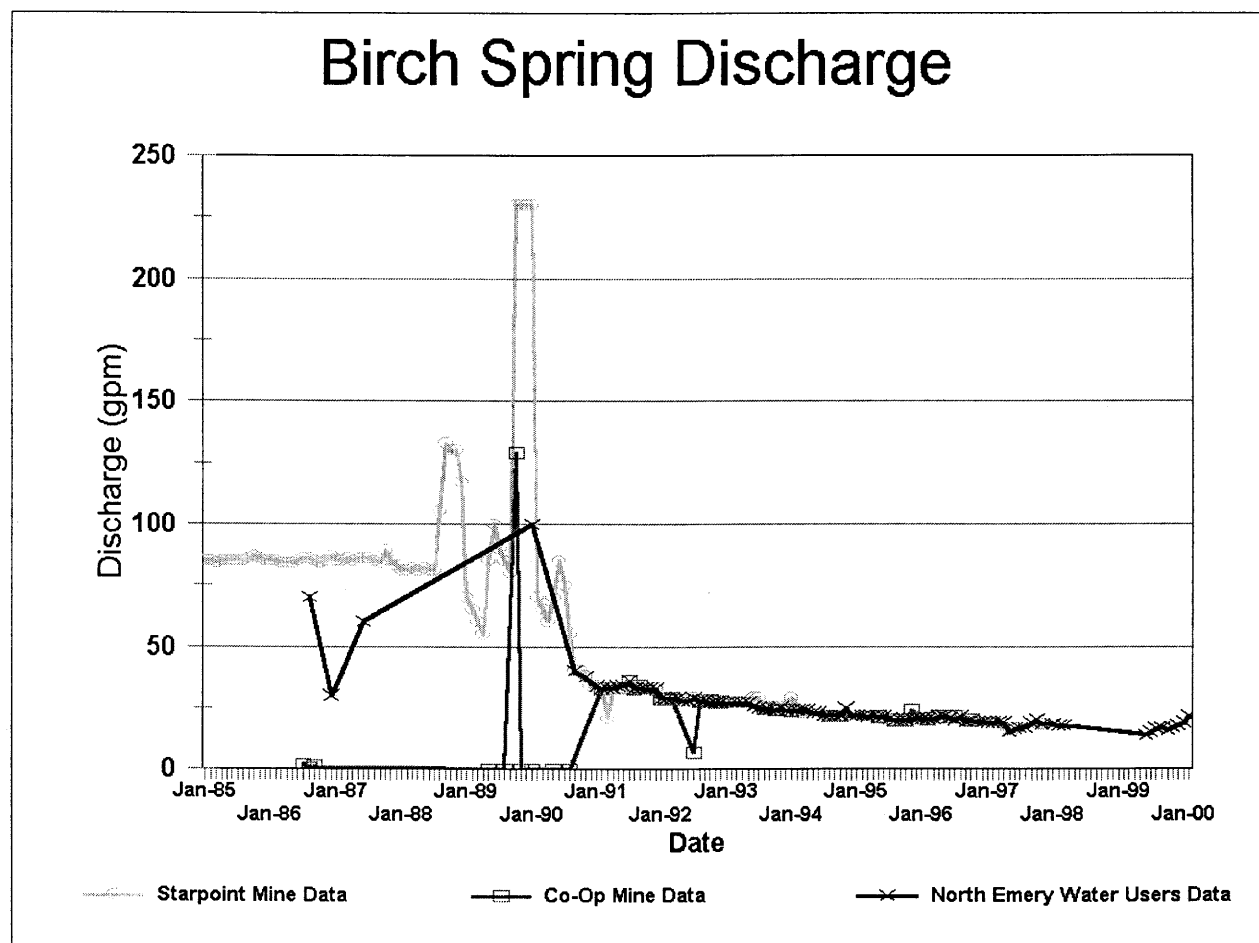
- Figure 1 presents current and past discharge data reported in the Star Point Mine, permit no. ACT/007/006; the Bear Canyon Mine, permit no. ACT/015/025; and the North Emery Water Users Association (NEWUA). The raw data are tabulated in Appendix A.

- Based on NEWUA records, flow at Birch Spring declined from 33 gpm in February 1990 to about 19 gpm in 1997, with a 16 gpm low flow recorded May 1997, Figure 1. This decline in flow could result from the drought beginning in 1987 through early 1993. Flows continued to decline to a low of 14 gpm recorded on June 1, 1999. Flows appear to be recovering from this low and the last recorded spring discharge rate provided from NEWUA was 23 gpm on February 18, 2000.

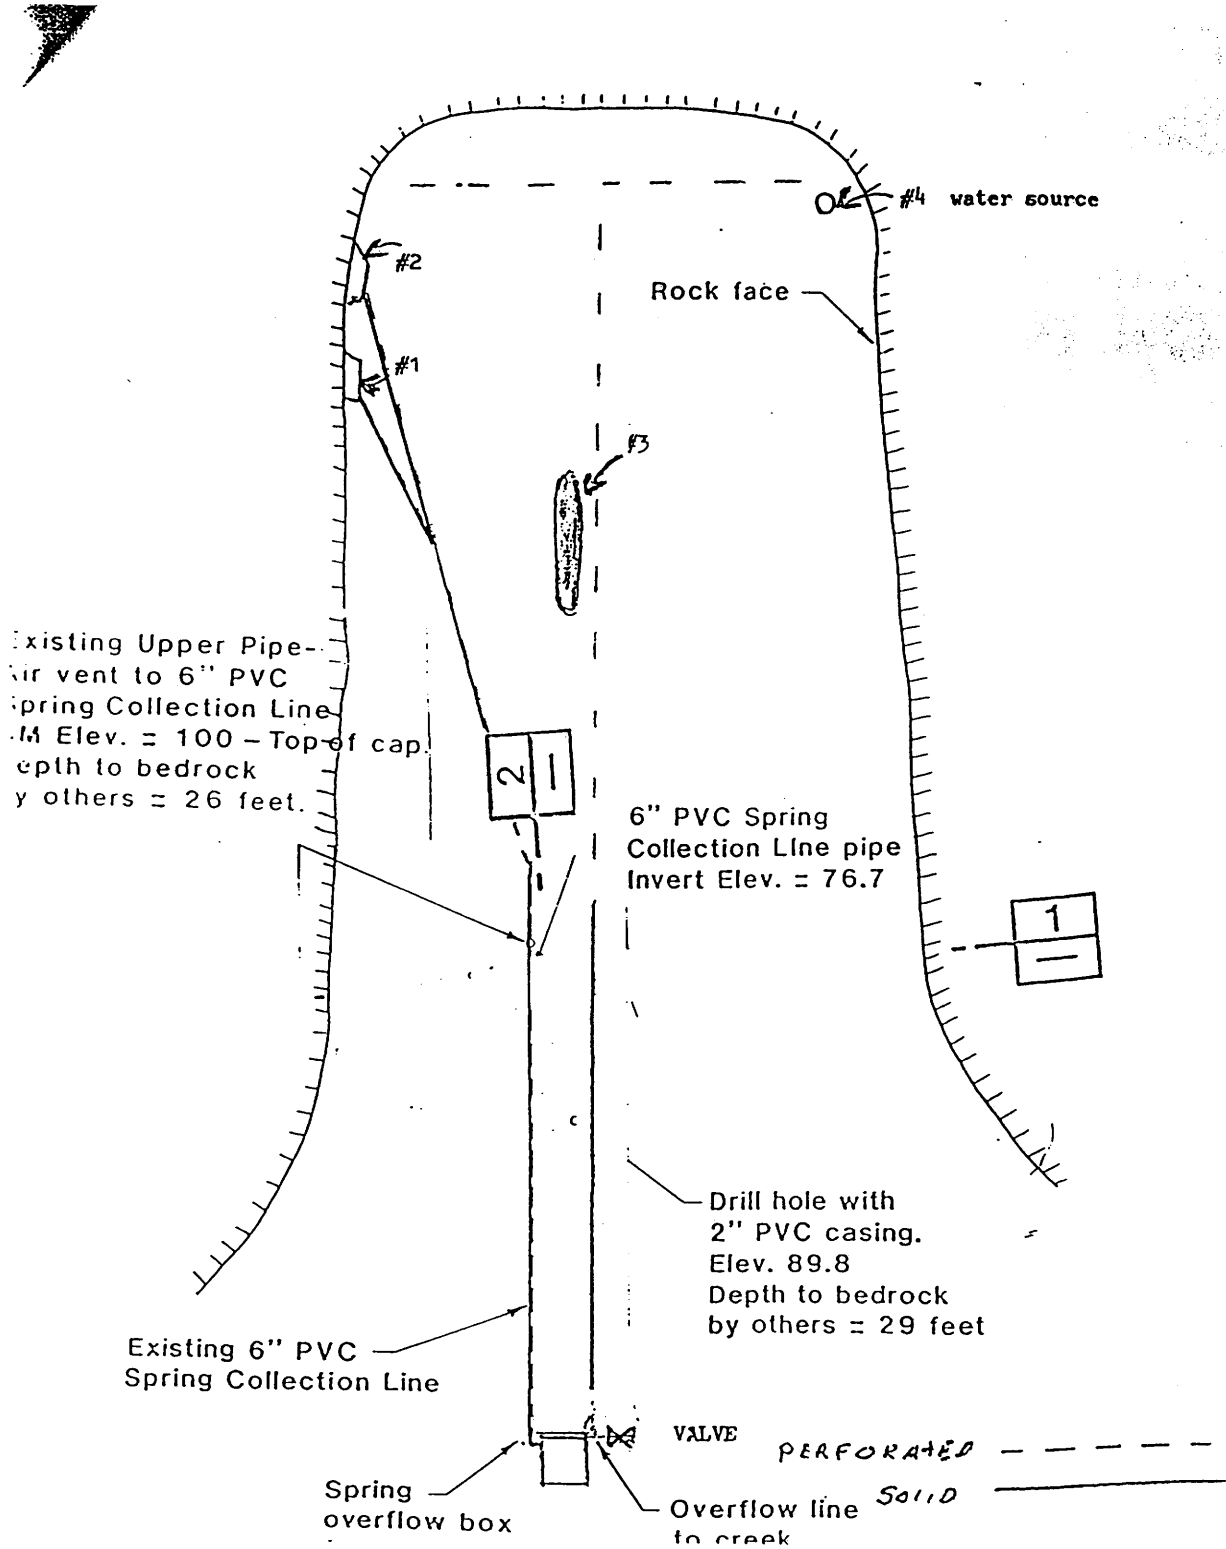
Spring Source #2 is located on the west side of the alcove and is the up gradient source #2 as shown in Map 1. Silt and sediments were noted in the gravel filter.
